# Combined ground freezing application for the excavation of connection tunnels for Centrum Nauki Kopernik Station - Warsaw Underground Line II

## ABSTRACT

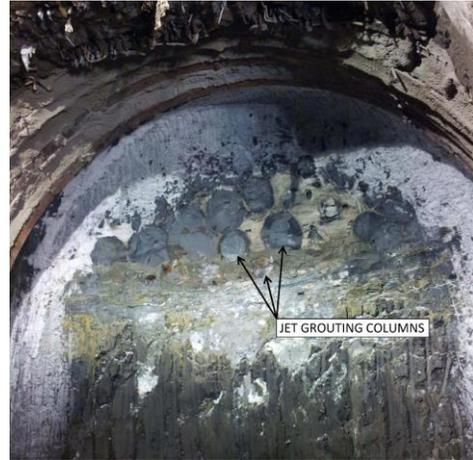
Figure 11. Face of the South East tunnel at 4th rib.

Figure 11 shows the jet grouting columns carried out from the East shaft before the collapse, encountered during the excavation of the first part of the tunnel.

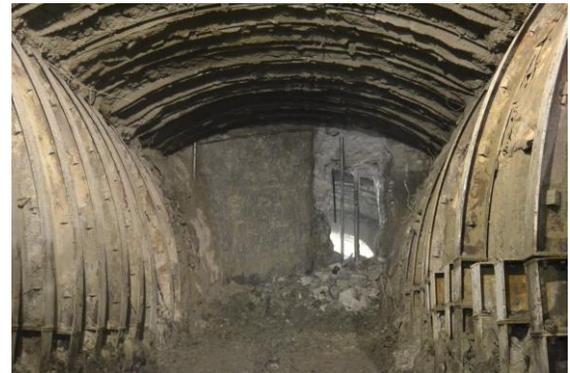
Figure 13. Central tunnel in the proximity of the last barrette to be demolished. On the right side the deactivated freezing pipes.

Figure 13 shows the excavation of the central tunnel in the proximity of the last *barrette* to be demolished. On the right side the deactivated freezing pipes are visible.
